FINAL REPORT

Rehabilitation and Construction of Water Supply Systems in Tusheti Region:

Phase 2: Implementation

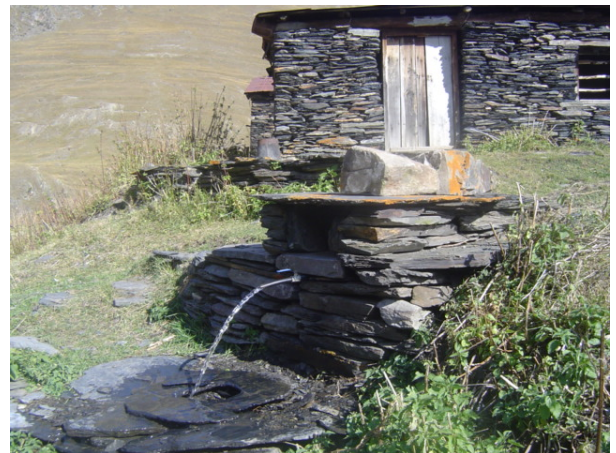
Photo 1: Public Water Point in Parsma

In Parsma, three public water points were connected and there are five points at which the water pipeline splits to supply different areas of the village. In Baso there are four public water points and two pipeline splits.

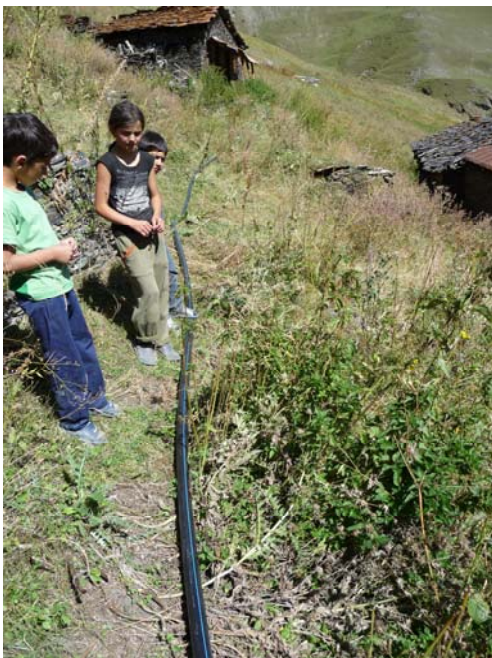
Photo 2: Connected water pipeline in Chesho

In Chesho the water catchment zone was newly constructed and the pipeline was connected and laid under the ground. Water flow was tested and there was good pressure in the village.

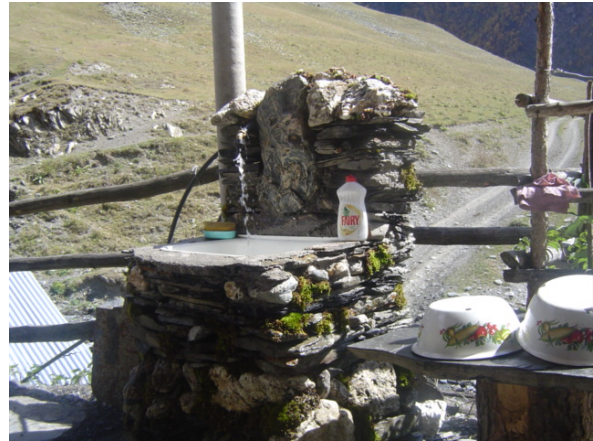
Photo 3: Newly constructed water point using old materials

A public water point was built in the village and there are five points where the pipeline splits to other parts of the village.

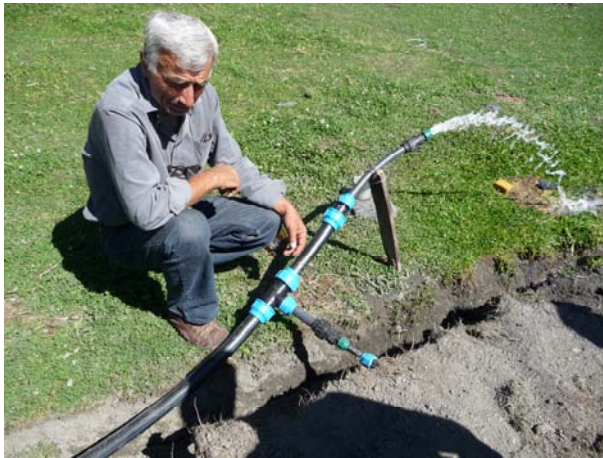
Photo 4: Testing water pressure in Dano

In Dano the catchment zone was constructed and the water pipeline connected and laid in earth channels prepared by the villagers. One public water point was renovated and there are four points at which the pipe splits to supply other parts of the village.

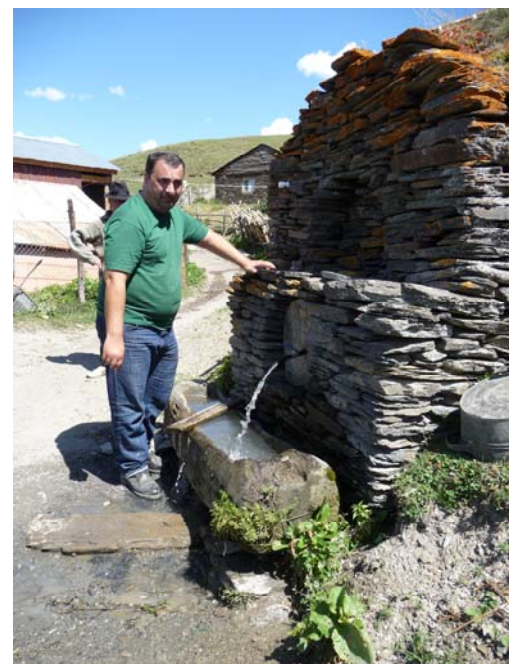
Photo 5: Public water point in Vestomta

The works in Vestomta were completed in early September. Transport to this village was very difficult as there were no roads. All materials were transported by horseback. However it was not possible to transport the protective covers for the newly constructed catchment zone due to their weight. This meant that the ACF and local engineer had to design an alternative and lighter design. Following construction of the catchment zone the water was connected to the village. The water feeds two public water points and there are three points at which the pipe splits.

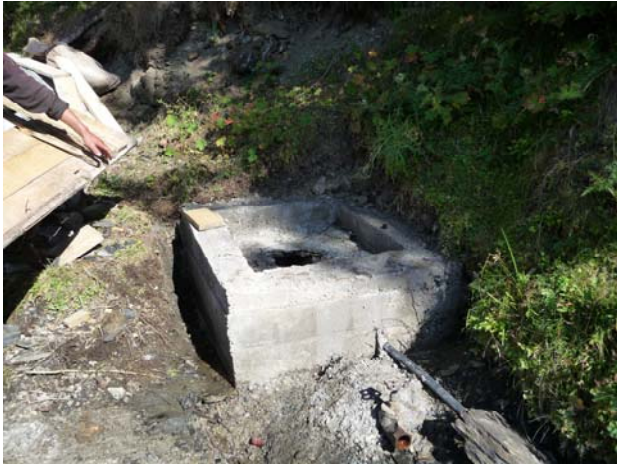
Photo 6: New catchment zone in Beghela

A new catchment zone was prepared in Beghela and the pipeline laid underground. The water is now connected and one public water point was constructed.

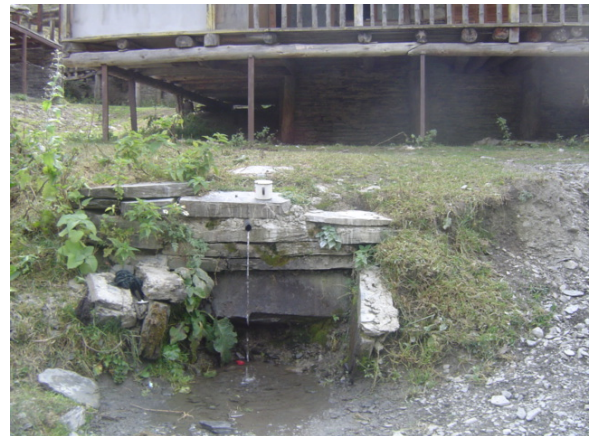
Photo 7: Water point in Khiso

There was no need to build a new catchment zone in Khiso, but ACF constructed a new 3,000 litre reservoir to store water. The pipeline was installed and insulated. Part of the pipeline that runs above a river required iron supports to secure it. There are four public water points in the village and four splits in the pipeline to supply other parts of the village.
